Manhole Inspection Summary

Manhole # S11II1001MH

Insp Date: **5/24/07 1:36 PM**

Location Address: **4401 REISTERSTOWN RD**

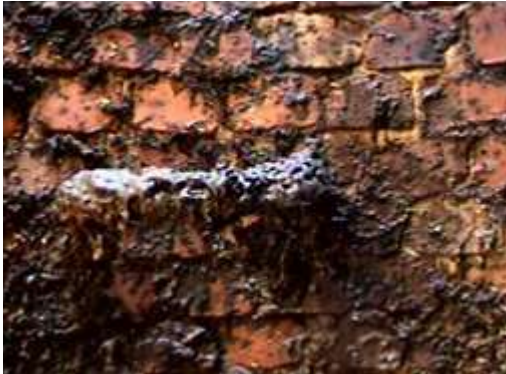
Defect 1

Count: **5** Missing: **0** ☒ **Corroded**

☒ **Evidence Of Surcharge** Depth: **4** (ft.) ☐ Active Surcharge Present

CORRODED RUNG/ EVIDENCE OF SURCHARGE

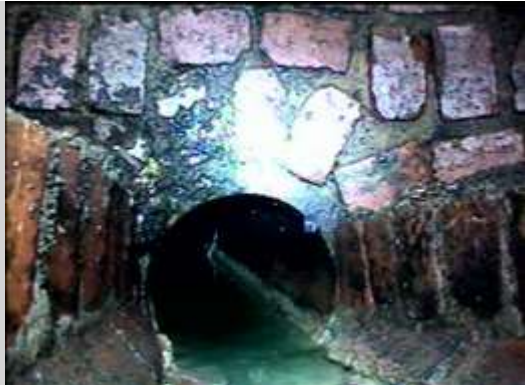
12 O'Clock Outflow

8 in. Circular Gravity Sewer
Pipe Out @ 12 O'Clock

Pipe Height: (in.) Direct
Pipe Material: **Clay** ☐ Pipe Lined
Invert Depth: **9.94** (ft.) Flow Characteristics: **Slow**
Deposits: ☐ None ☐ Mud ☐ Sludge ☐ Debris ☒ Grease
Silt Depth: **0.25** (in.) Deposits Extent: **Light**
Infiltration: **None** Pipe Seal Cond: **Sound**

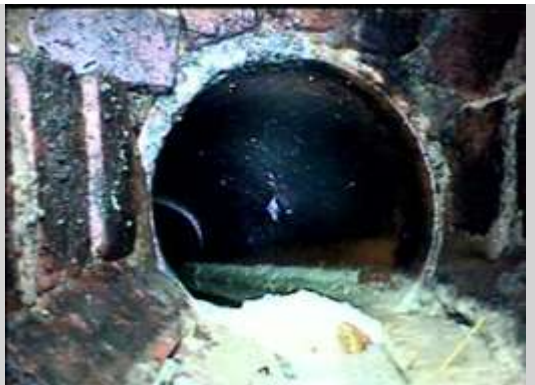
3 O'Clock Inflow

8 in. Circular Gravity Sewer
Pipe In @ 3 O'Clock

Pipe Height: (in.) Direct
Pipe Material: **Clay** ☐ Pipe Lined
Invert Depth: **9.71** (ft.) Flow Characteristics: **Slow**
Deposits: ☐ None ☐ Mud ☐ Sludge ☐ Debris ☒ Grease
Silt Depth: **0.25** (in.) Deposits Extent: **Light**
Infiltration: **None** Pipe Seal Cond: **Sound**

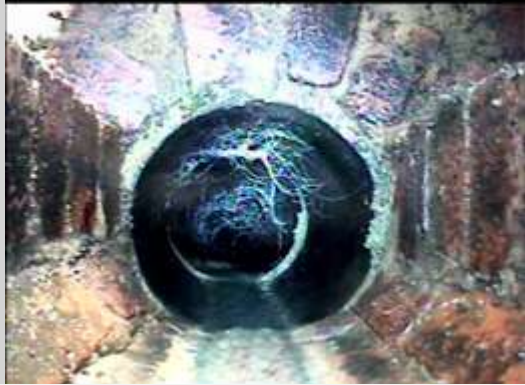
6 O'Clock Inflow

8 in. Circular Gravity Sewer
Pipe In @ 6 O'Clock

Deposits: ☒ None ☐ Mud ☐ Sludge ☐ Debris ☐ Grease
